Mobile Intel[®] Celeron[®] Processor at 466 MHz, 433 MHz, 400 MHz, 366 MHz, 333 MHz, 300 MHz, and 266 MHz Specification Update

Release Date: June 2002

Order Number: 244444-033

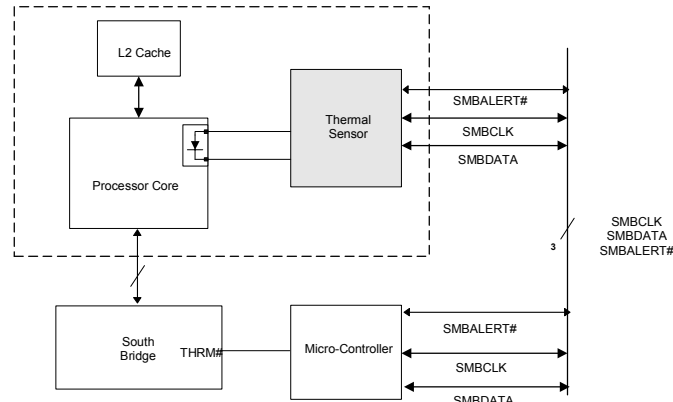
Figure 1. An Example of Microcontroller Driven Thermal Management

H29. Thermal Sensor May Assert SMBALERT# Incorrectly

Problem: The Intel Celeron Processor Mobile Module has a thermal sensor that monitors the processor core's temperature. Please note that desktop systems could have a similar thermal device. The thermal sensor asserts SMBALERT# if the processor temperature exceeds the temperature limits set in the Alarm Threshold Registers (T_{HIGH} , T_{LOW}). It also sets the corresponding Status Register bits to identify the cause of the interrupt. Figure 1 gives one example of how the SMBALERT# signal could be used in a system.

Implication: There is no system impact from this erratum if temperature polling is used for processor thermal management. If the SMBALERT# interrupt is employed to manage processor thermal sensing, then servicing the false interrupt may result in premature system action depending on the software and hardware implementations used. The rate of the false interrupts is less than the auto-convert rate of the thermal sensor.

Workaround: Three different (mutually exclusive) workarounds are possible:

1. Before servicing an interrupt from the thermal sensor, read and compare the processor thermal reading with the threshold limits (T_{HIGH} or T_{LOW}). Figures 2 and 3 provide basic flowcharts for the implementation of this workaround in an interrupt driven system.
2. If the firmware implemented polls the Status Register only, then before taking any action, re-read the temperature register and do a comparison with the alarm threshold limits (T_{HIGH} or T_{LOW}) to determine if the value is actually still within the temperature window.
3. Use a temperature polling scheme to monitor the processor temperature.
